***Upgrade Solutions Equals Improved Performance***

***Get the right Control Valve Trim from CPC with an upgraded solution***

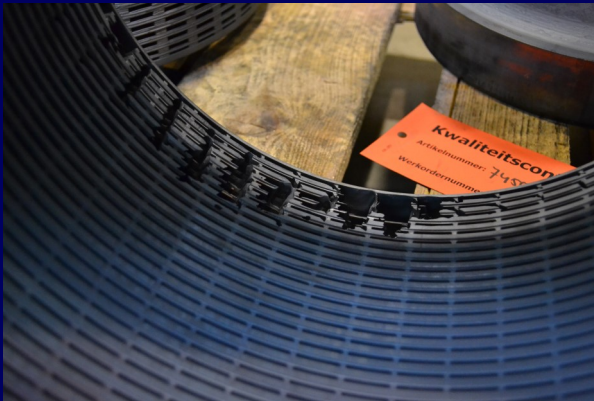
Wrong Material selection

When the wrong material selection is made or when the supplied trim is not produced correctly to the process conditions CPC can design and engineer the correct solution for the application increasing uptime and reducing maintenance costs.

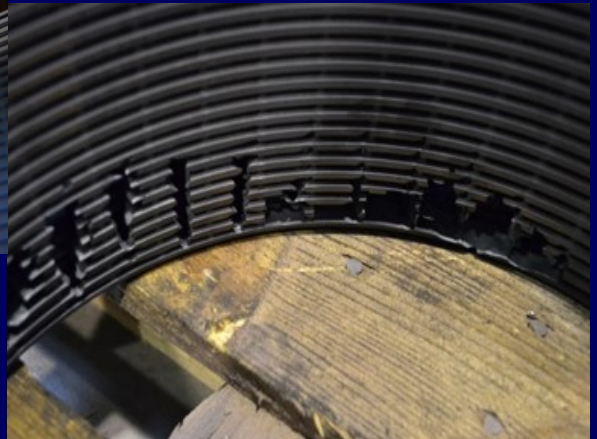
Incorrect number of pressure reduction stages

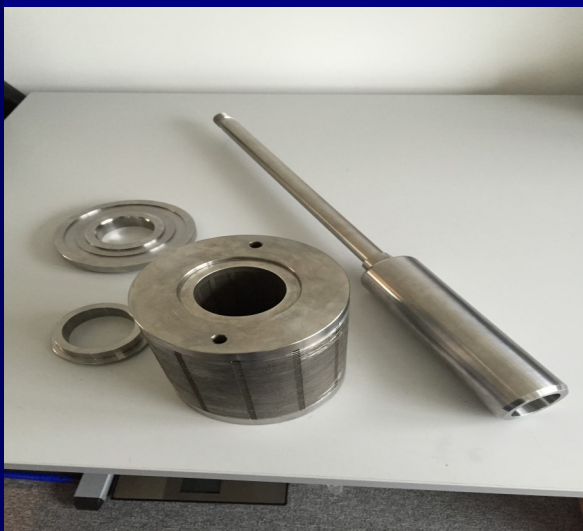
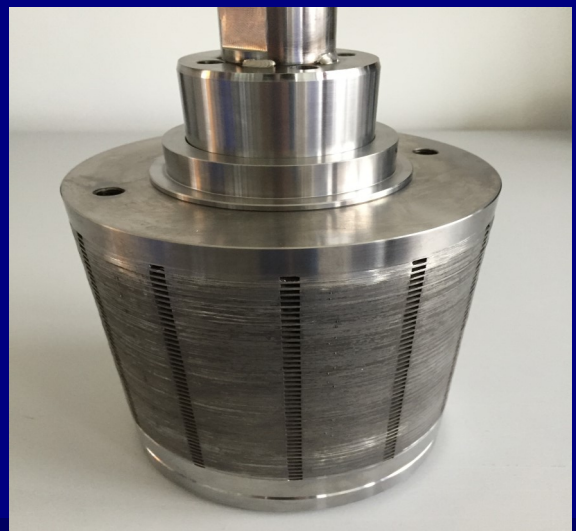
Power Station Example

CPC were approached by a UK Power Station to help solve an ongoing repeat failure of a number of Feedwater Control Valves (HP, MP & IP)

CPC's design included a number of improvements including relocating the balance seal off the plug and into the cage plus the addition of labyrinth grooves on the plug to help reduce the velocity at the seat area.

- Piston rings failing on the plug
- Cavitation on the seat face
- CPC Design putting a Balance seal in the cage replacing the piston rings plus adding labyrinth grooves on the plug to reduce cavitation.

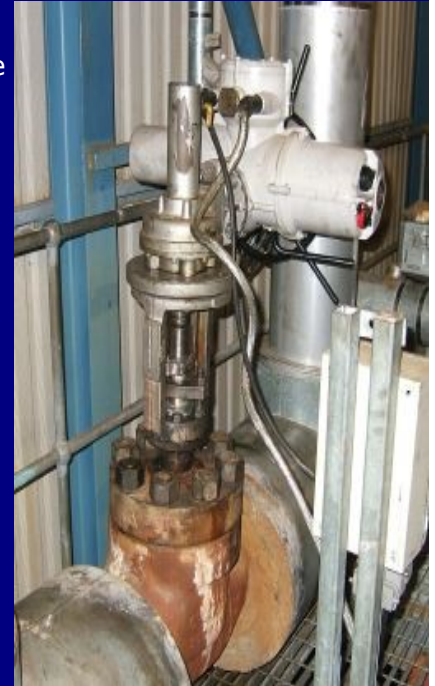
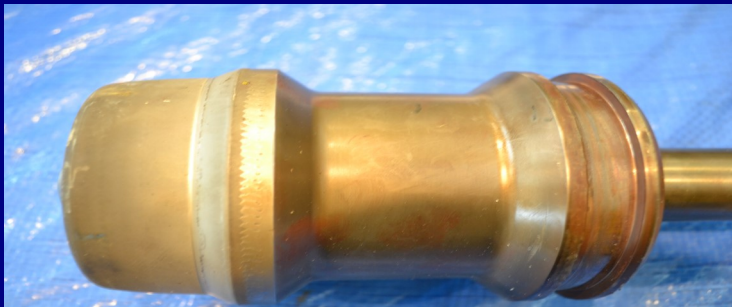
ENGINEERED TO SOLVE THE PROBLEM

After technical evaluation of the operating conditions and the current OEM valve we identified and presented a number of improvements to the customer.

It was clear that the OEM technology for this application was not up to the job so CPC engineered a trim solution that would fit directly into the existing OEM valve with no alterations to the body or actuator assembly.

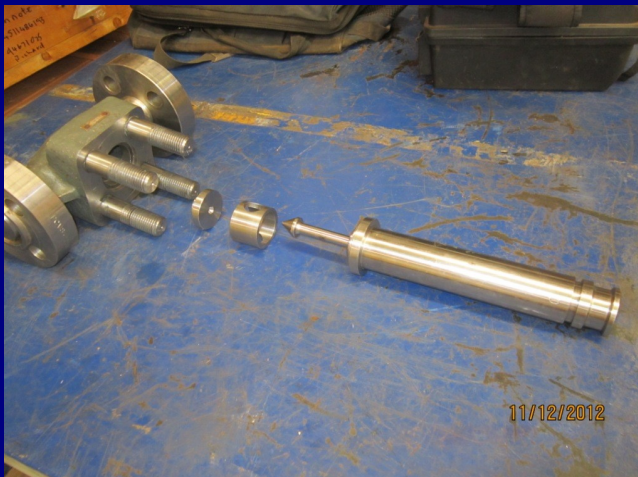
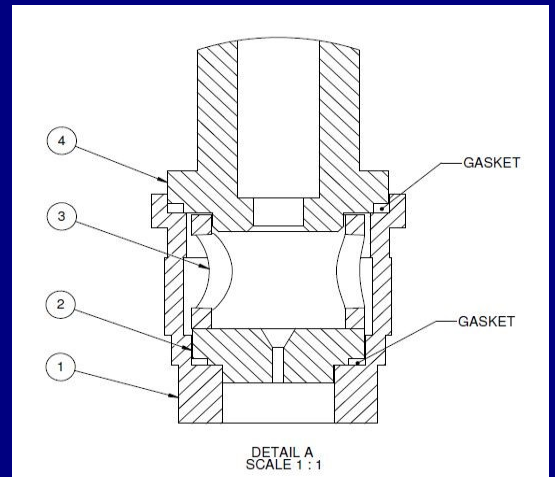
*OEM TRIM (Continually Failing/Poor Design)*

CPC were asked by an Oil & Gas operator in Australia to solve a big problem they were experiencing on an unmanned platform. The problem was with a very high pressure drop low flow valve that was constantly failing due to poor design.

CPC quickly identified the root cause for the failure and presented the solution to the end customer. The customer involved a varied number of technical decision makers who all agreed the proposed solution was the right one to solve the problem.
